RE: Parker Hannifin Corporation, Automotive Connectors Division, Kennett, Missouri EPA ID# MOD020350245

MISSOURI DEPARTMENT OF NATURAL RESOURCES CLOSED FACILITY OVERSIGHT INSPECTION

Parker Hannifin Corporation Automotive Connectors Division Highway E Kennett, MO 63857 (573) 717-2208

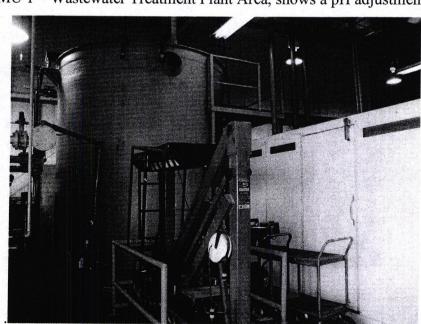
<u>Inspection Observations</u> - The pH adjustment tank remains in place and in use. The inspector requested that PHC provide the approximate dates that the plant was dismantled and disposed. The concrete floor around the tank appears to be clean and free of cracks and stains. No evidence of spills or release was observed during the inspection.

SWMU 1 – Wastewater Treatment Plant Area, shows a pH adjustment tank

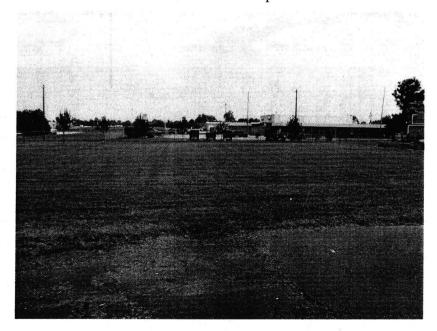
SWMU 2 – Former Surface Impoundment Area.

<u>Inspection Observations -</u> The inspector observed that this area is currently covered by native soils compacted over the entire area and sloped to promote drainage and prevent ponding. A mixture of native grass has been planted on the soil cover to prevent erosion and promote evapotranspiration. The vegetative cover was inspected for growth of any inappropriate vegetation, presence of ponding water, erosion, subsidence, cracks, or burrow holes. The cover was in satisfactory condition and free of weeds, stressed vegetation, ponding etc. Regular mowing controls the weed growth.

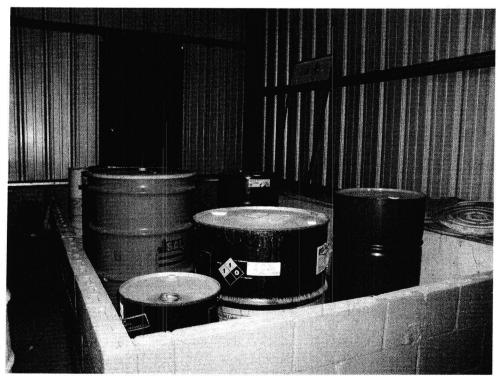
<u>Inspection Observations</u> - The tank storage area is now enclosed and converted into the hazardous waste storage building. The inspector requested that PHC furnish dates of dismantling, the method of waste disposal, and results of closure sampling, if any sampling was performed.

SWMU 3 – Tank Storage Area, converted into the hazardous waste storage area.

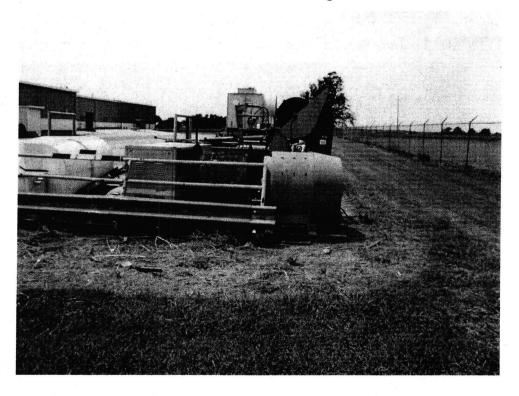
SWMU 4 - Container Storage Area

<u>Inspection Observations</u> - This area is now covered by native soil and looks satisfactory. The area is now used for storing scrap material. The inspector requested PHC to furnish details of disposed materials and results of closure sampling, if any sampling was performed.

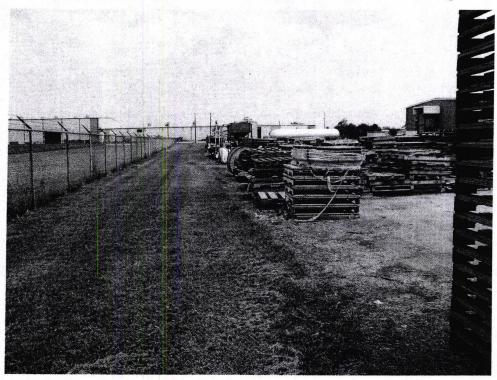
<u>Inspection Observations</u> - The two oil-stained areas described in the RFA are now covered by native grass. The vegetative cover was green and no stressed vegetation or stains were observed. Overall, the area looked satisfactory.

SWMU 5 - Oil Stained Areas, now covered with well maintained grass

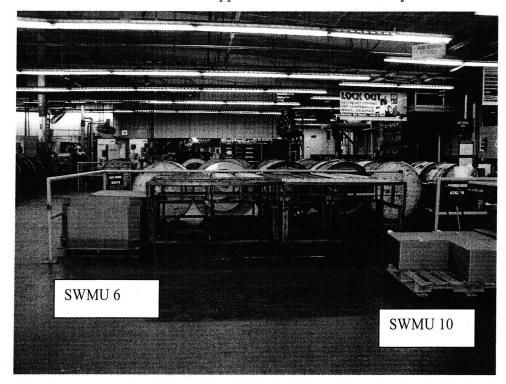
SWMU 6 - Furnace and Stripper Air Pollution Control Systems Area

<u>Inspection Observations</u> - The area looks clean and is covered by a concrete floor. The concrete floor is free of cracks and stains. No further activities at this area.

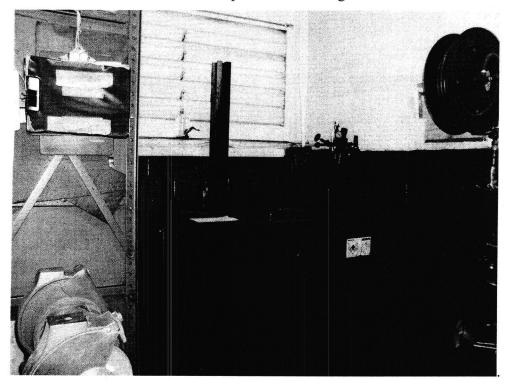
SWMU 7 - Shuttle Repair and Cleaning Station Area

<u>Inspection Observations</u>. The unit is used for cleaning small parts. The station is cleaned and maintained on a regular basis. No evidence of spills or release was observed during the inspection.

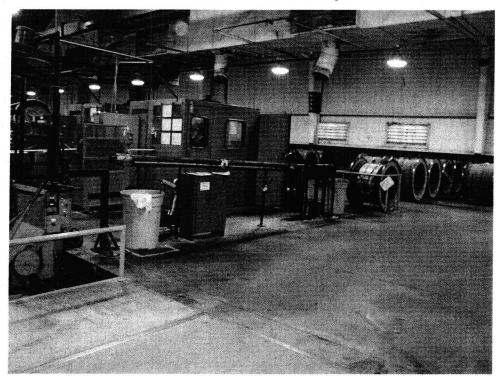
SWMU 8 – Waste Solvent Storage Area

<u>Inspection Observations</u> - This unit is no longer in use. The area looks clean and is covered by a concrete floor. The concrete floor is free of cracks and stains. No evidence of spills or release was observed during the inspection.

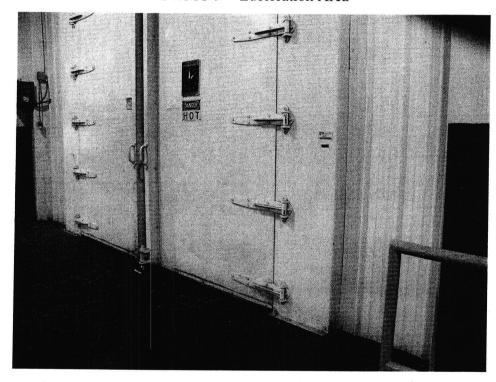
SWMU 9 - Lubrication Area

<u>Inspection Observations - Currently the unit uses a non-TCA lubricant.</u> The area looks clean and is covered by a concrete floor. The floor is free of cracks and stains. No evidence of spills or release was observed during the inspection.

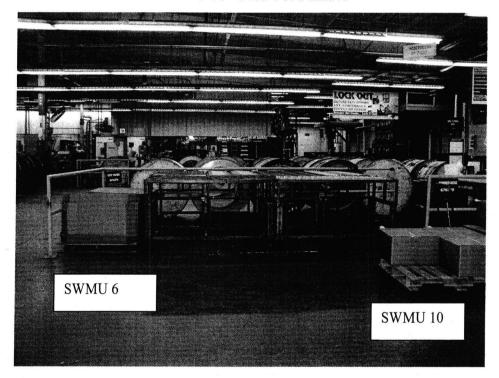
SWMU 10 - Melt Pot Furnace

<u>Inspection Observations</u> - Currently the area is covered by a concrete floor that looks clean. The concrete floor appears to be free of cracks and stains.

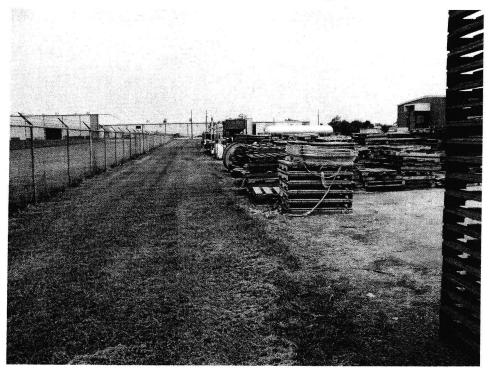
AOC A – Unused Solvent Storage Area

<u>Inspection Observations</u> - The area is partly covered by native soil and grass, and partly covered by asphalt pavement. No current facility activities are taking place in this area. The area was free of stressed vegetation, ponding, subsidence, and erosion. The asphalt area was free of cracks and stains.

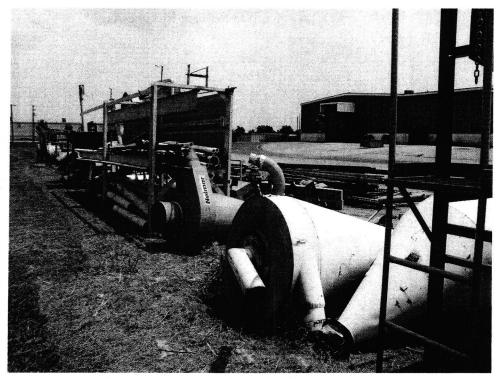
AOC B – Scrap Machinery Storage Area

<u>Inspection Observations</u> - The area is currently used for storing wooden pallets and scrap machinery stored on pallets and the ground. Removal of scrap machinery/junk from this area is performed on a regular basis. The area is free of grease/oil contamination.

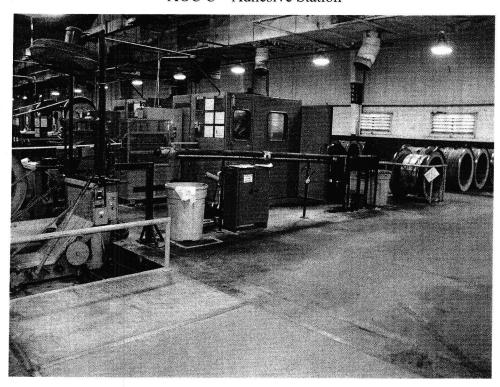
AOC C – Adhesive Station

<u>Inspection Observations</u> - The adhesive pots are mobile and placed in the process run at different points based on the specifications of the product run. A clean concrete floor, which is free of cracks and stains covers the area.

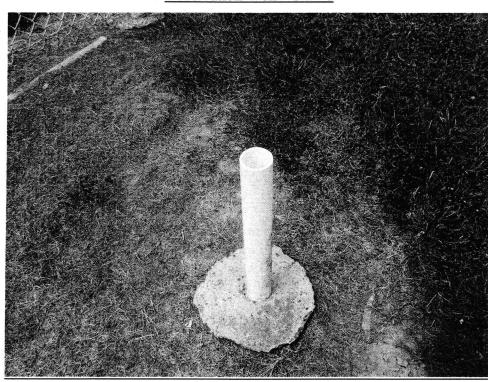
Observation Well - OW- 1

<u>Inspection Observations</u> - The identification numbers of the two wells are not clearly marked and the surface well seals are loose. Currently the facility is not using these wells for sampling. The wells were installed before 1980; hence, they were not registered with the department's Division of Geology and Land Survey. None of the wells have been plugged in accordance with the Missouri Well Installation Rules (10 CSR 23-4.080) administered by Division of Geology and Land Survey. The facility gave assurance that the existing wells (and any other that are subsequently located) will be plugged according to the applicable rules.

- The department recommends PHC plug and abandon the monitoring and observation wells.
- The department recommended PHC submit a Description of Current Conditions Report (DCCR) to update changes at the facility including the history of the SWMUs and AOCs since the April 1989 RFA.
- At the time of the inspection, the department suggested PHC consider entering into a letter of agreement for Expedited Corrective Action. After reviewing the documentation for the clean closure of the Former Surface Impoundment and considering the finding of this inspection, the department feels that an Expedited Corrective Action Letter of Agreement may not be necessary for closing out the corrective action issues at the facility.
